# Repair instructions SIATA V360

Instructions for repairing the SIATA valve V360

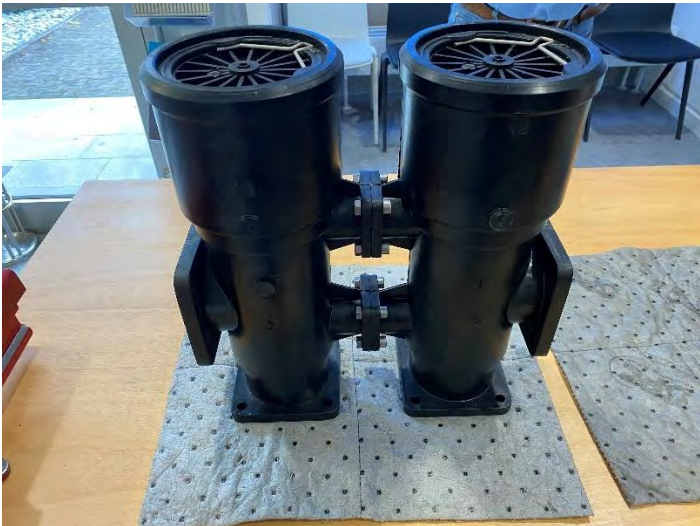
Fig.1 SIATA valve V360

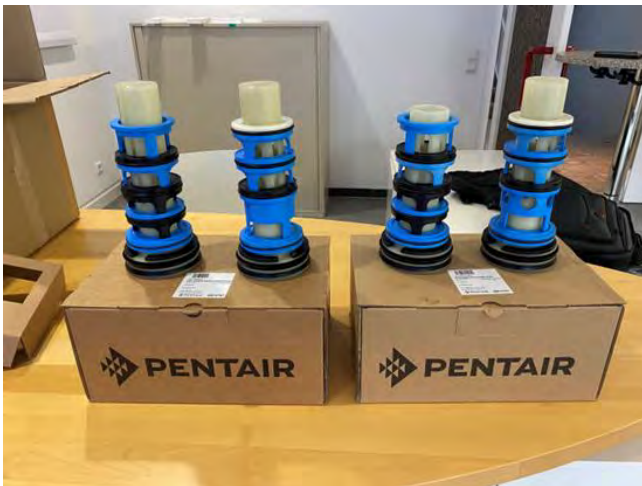
The piston service kit consists of 2 pistons complete with attachments.

Fig.2 Piston service kit

Fig. 2 left: Piston service kit HERCO part no.: 00365639 for standard valve\*

Fig. 2 right: Piston service kit HERCO part no.: 00366328 for filter valve\*

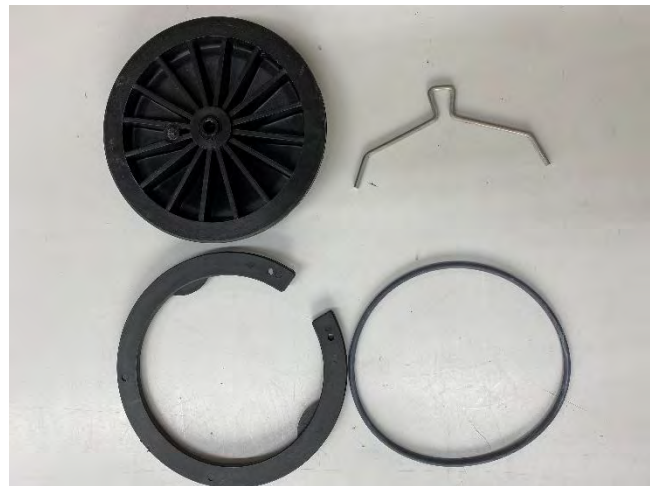
Fig. 3 Piston cover with O-ring, Segor ring and clamp

Fig. 3: 2 x piston cover HERCO art. no.: 00365576 (suitable for standard and filter valve)\*

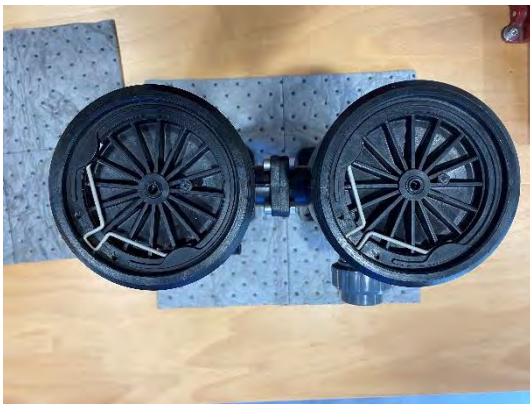
Fig. 5

- 2) Place the valve on a firm surface with the piston caps facing upwards (Fig. 5) and remove the safety clip (Fig. 6).

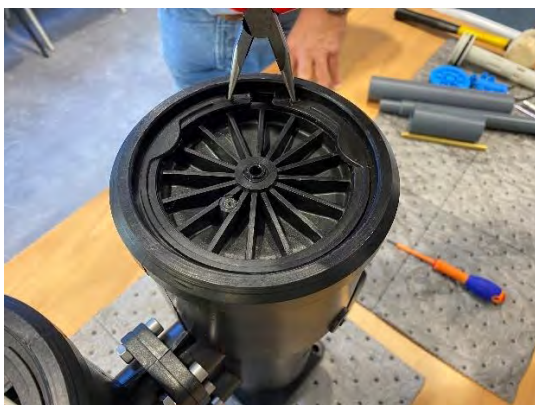
Fig. 7

- 3) Next, remove the Seger ring (Fig. 7) and remove the piston cover with O-ring (Fig. 8).

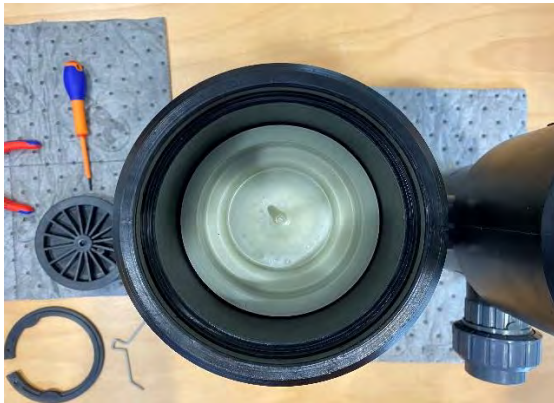
- 4) Now remove the piston (Fig. 9). With older valves, the piston may be difficult to move. In this case, lay the valve on its side. Use a plastic or wooden ejector in conjunction with a rubber mallet and apply light, circular blows to the piston shaft (Fig. 10 + 11) until you can remove the piston (Fig. 12).

Fig. 9 oblen top view

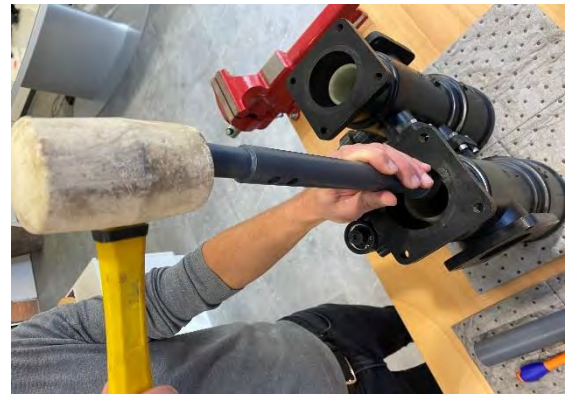
Fig. 10 Ejector on back of piston

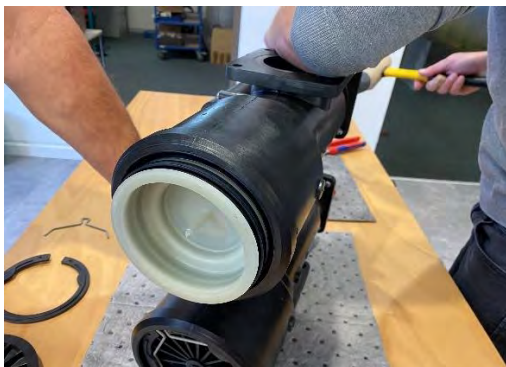
Fig. 11 Expelling the piston

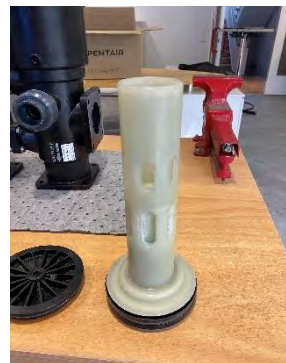
Fig. 12 Piston with O-ring

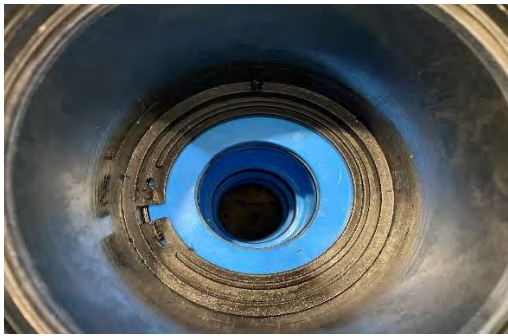
- 5) Next, remove the inner circlip (Fig. 13 and 14).

Fig. 13 circlip inside

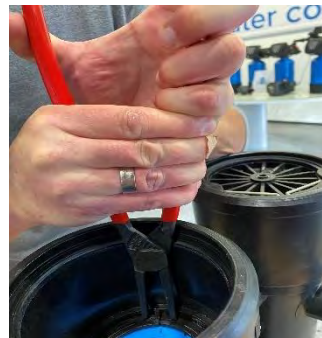
Fig. 14 circlip pliers for removal

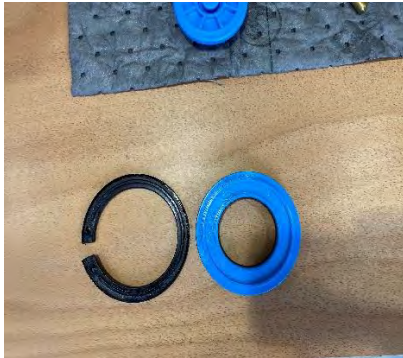
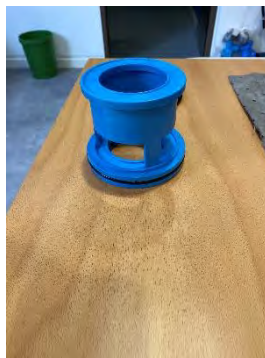
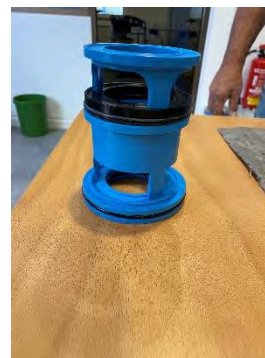
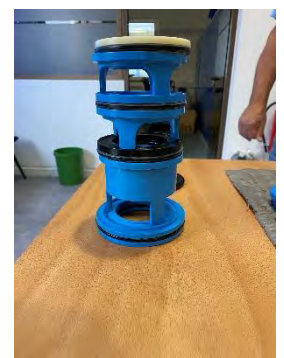
- 6) You can now remove the sealing discs with O-rings and spacers. Place them on your work surface, rotated by 180° (Fig. 15 - 18), in the **exact** order in which you removed them.

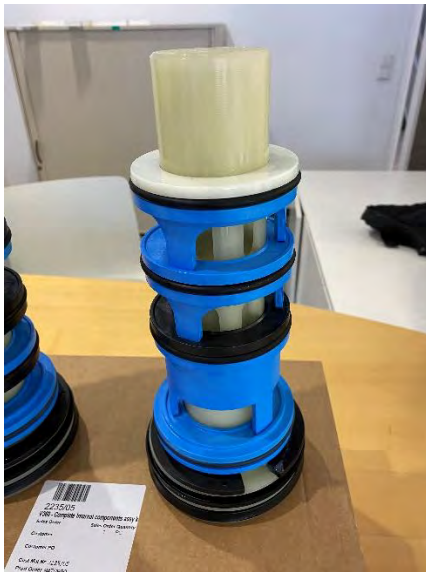
Fig. 19

- 7) Now remove the matching piston with sealing discs, O-rings and spacers (Fig. 19) from the piston service kit and reassemble the SIATA V360 in reverse order. Ensure that the sealing discs and O-rings are seated correctly (Fig. 20).

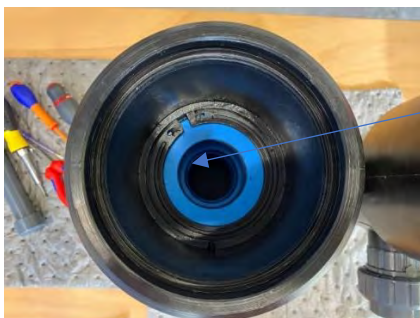
Fig. 21

- 8) You can tell whether all the O-rings are in the correct position after assembly by the fact that the inner Seger ring can be fitted in its intended position (Fig. 21) with little effort.
